AVIATION INVESTIGATION REPORT

A04A0111

LOSS OF CONTROL - COLLISION WITH TERRAIN

AEROSPATIALE AS-350D C-GVHB

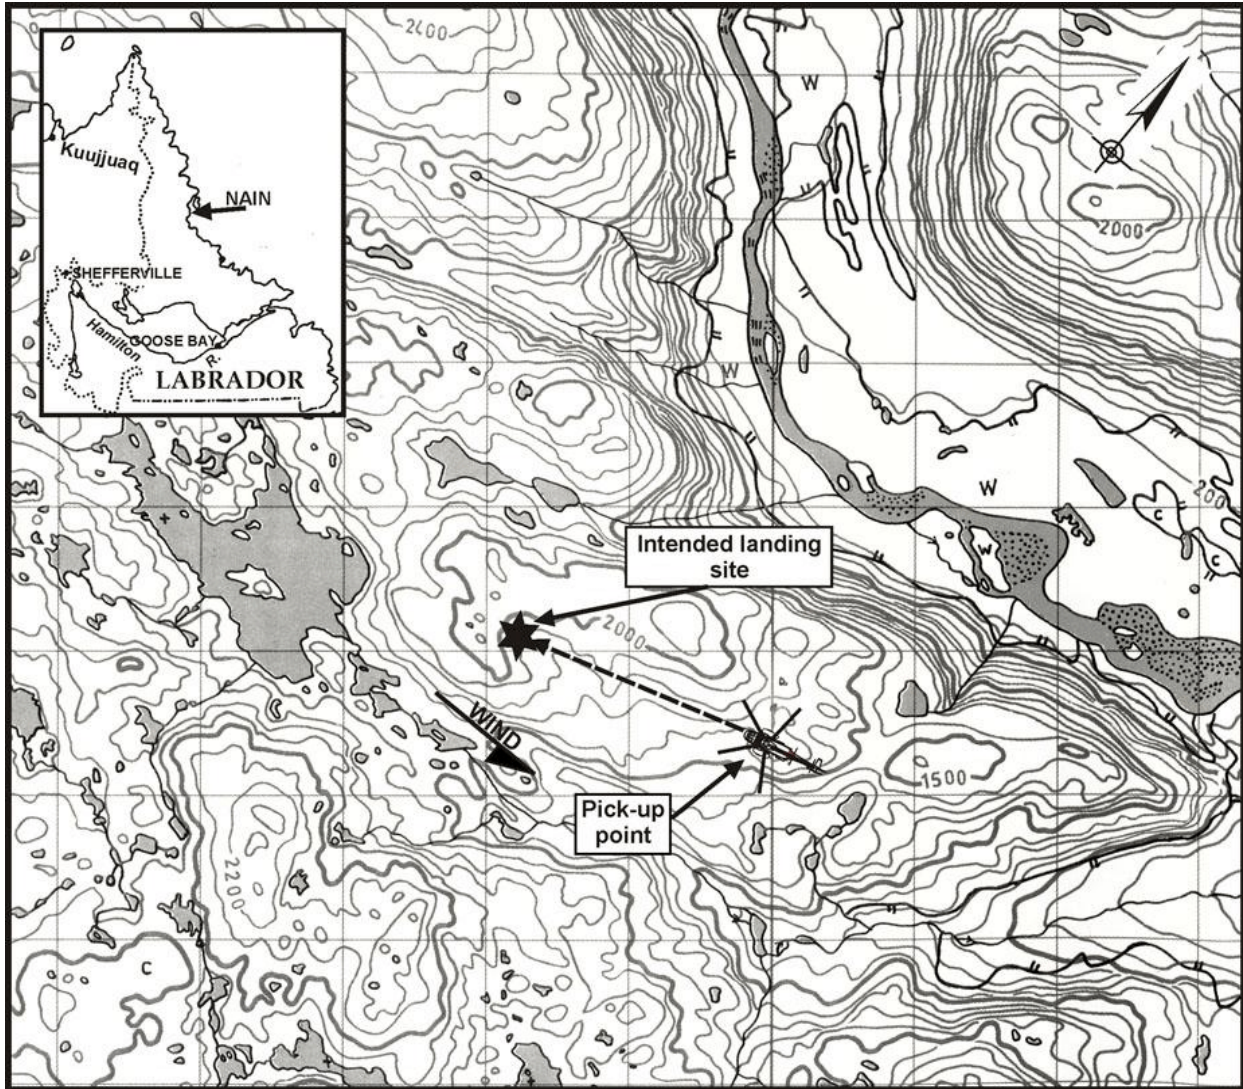
Appendix A – Site Map

The intended landing site was on the west side of the same ridge, approximately 300 feet higher in elevation than the previous site. The western edge of the ridge was L-shaped with the base of the L oriented north-south, and the stem oriented east-west. The base of the "L" was on the west side of the stem (see Appendix A). The top of the ridge line was 2100 feet asl and the landing site was located at an elevation of 1900 feet asl in the bowl formed by the two sides of the L. The prevailing winds were from the west and crossed the ridge at an angle of 90 degrees. The approach was flown directly into the centre of the bowl, without a reconnaissance pass.

The winds were light and westerly throughout the day of the accident. The intended landing site at which the pilot was going to drop the survey crew was 300 feet higher than the take off area and was in a bowl on the lee side of the ridge. Wind conditions are notoriously unpredictable in mountainous regions, and it is likely that the intended landing site was located in an area of down-flowing wind.
